APPENDIX D

TRAIL AND SITE OBSTACLE REPAIR DETAILS (MODIFIED BEST MANAGEMENT PRACTICES)

TELLICO OHV TRAIL SYSTEM

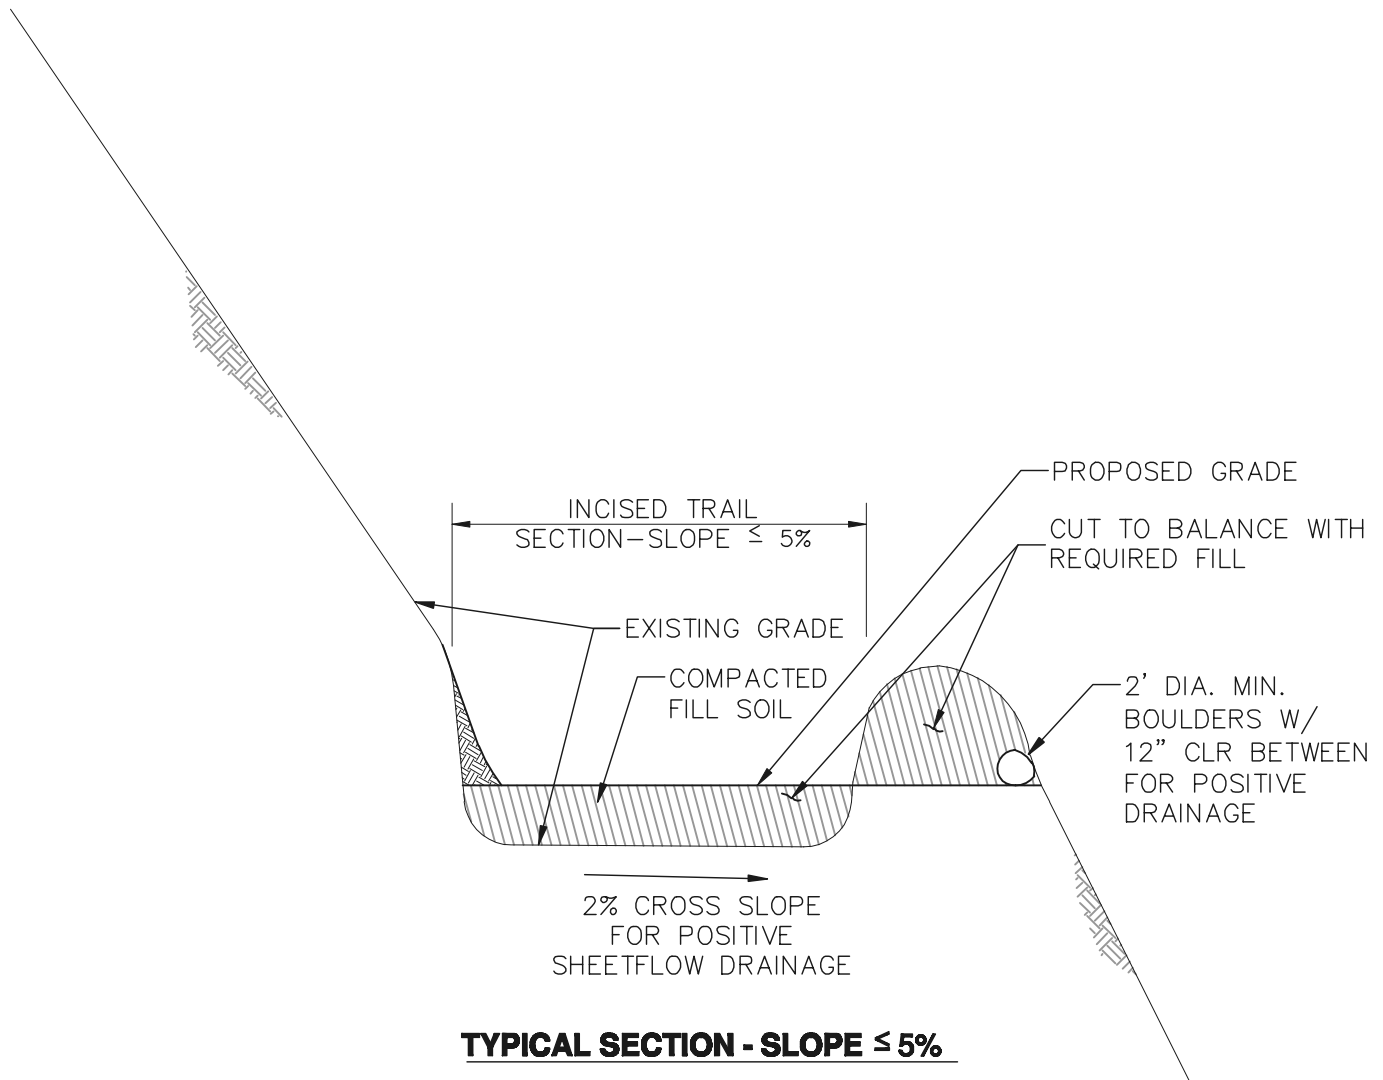
DETAIL-A

INCISED TRAIL REPAIR $\leq 5\%$ SLOPE

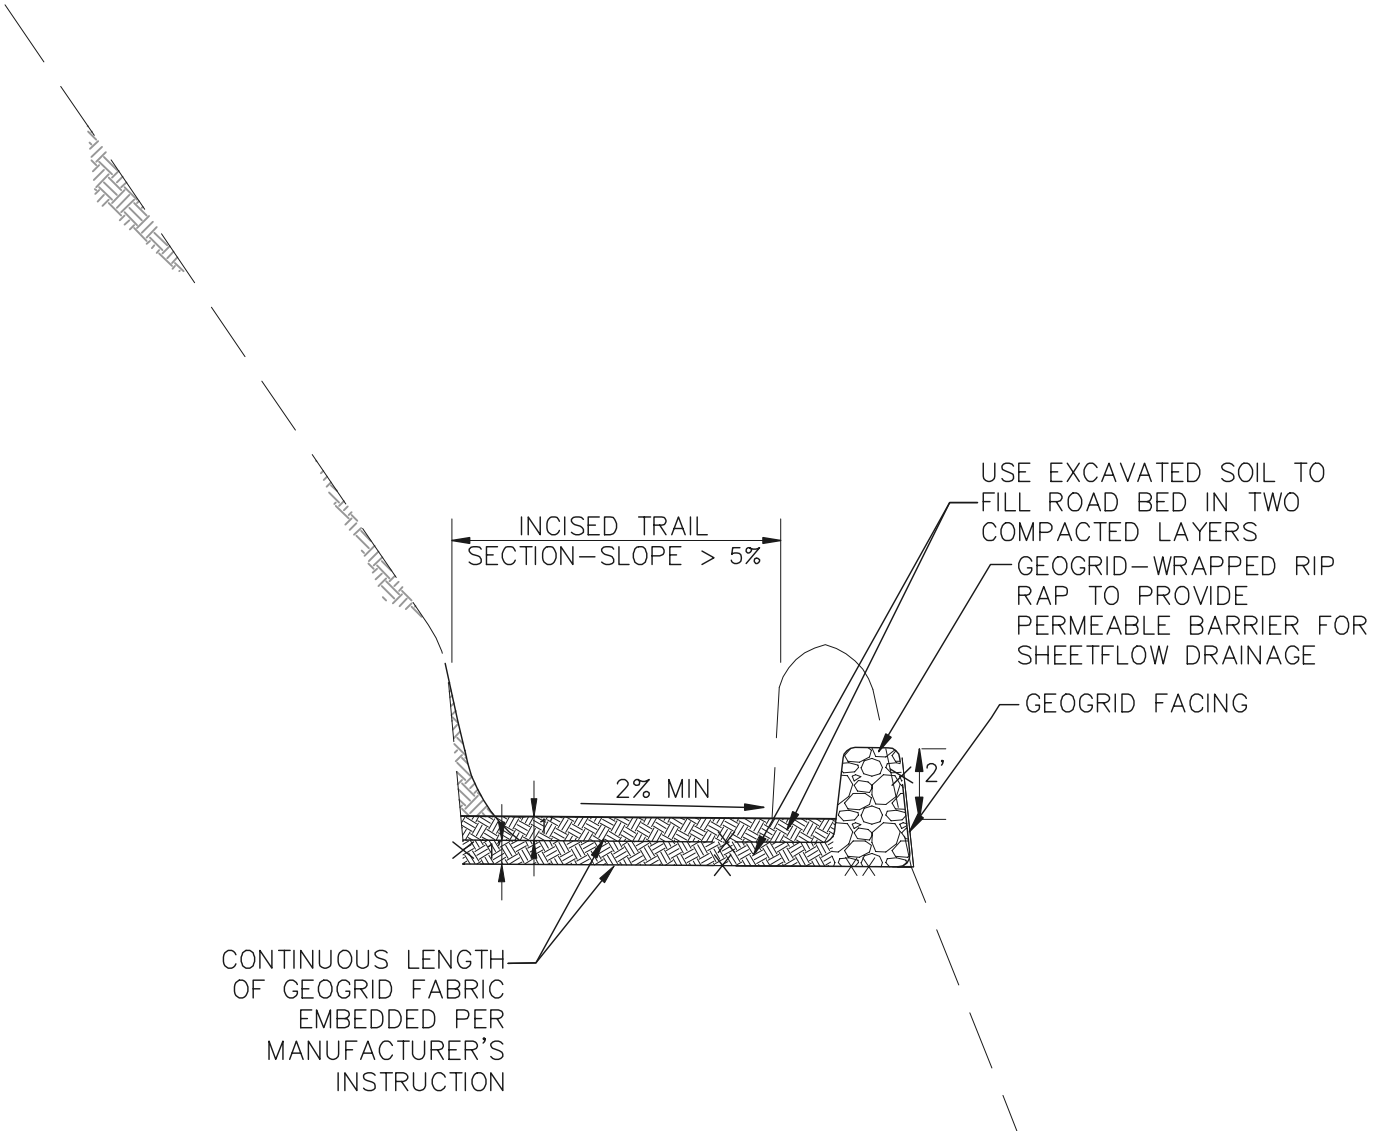
DETAIL-B

INCISED TRAIL REPAIR >5% SLOPE
